Char Development and Settlement Bridging Project (Phase IV Additional Finance) Bangladesh

**Expert opinion on bank development along CDSP III and IV
chars, and on scope of hydraulic and morphological study.**

Technical Report No. 1

September 2019

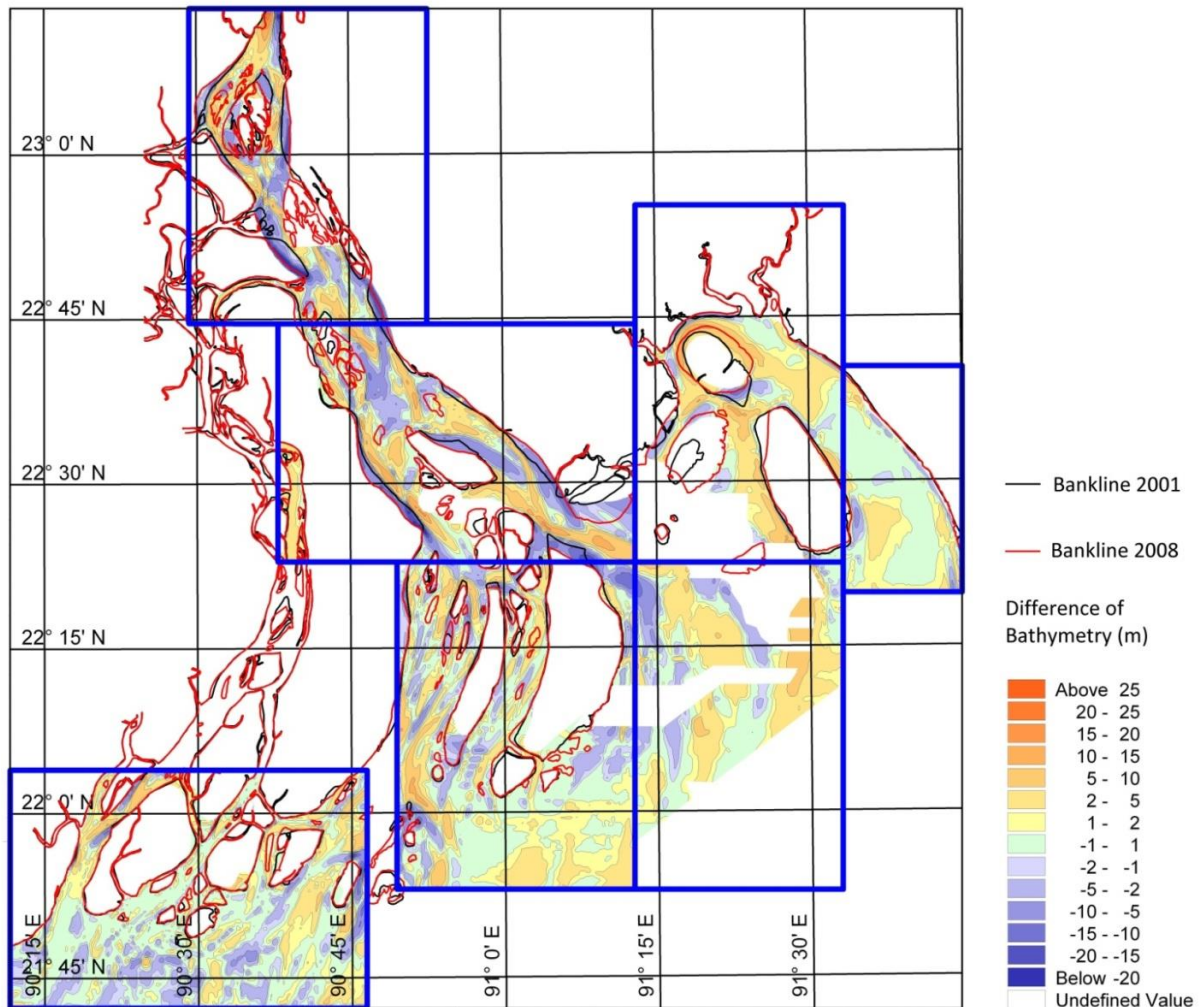
In the period 1999-2009 net erosion occurred in the 2 upper left boxes (being the lower Meghna main channel) of an average 71 million m³ per year. In the other 5 boxes on the east and south side sedimentation was dominant, in average totalling 347 million m³/year.

Looking in detail at the development around the CDSP area it is clear that in this area erosion was present in the period 1999-2009. So even before the start of CDSP IV the first symptoms of the present erosive trend were already visible.

Erosion and sedimentation patterns in Meghna estuary (from EDP-2011)

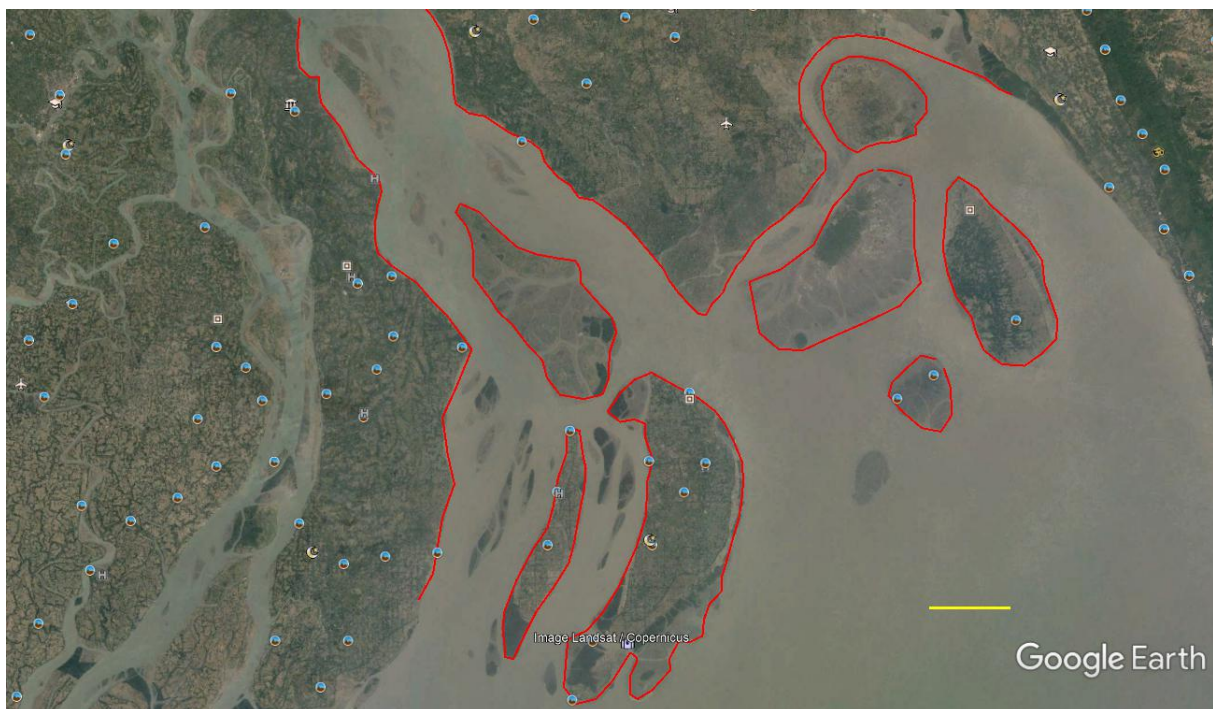
Satellite image of approximately 2015 showing schematized bank line in red

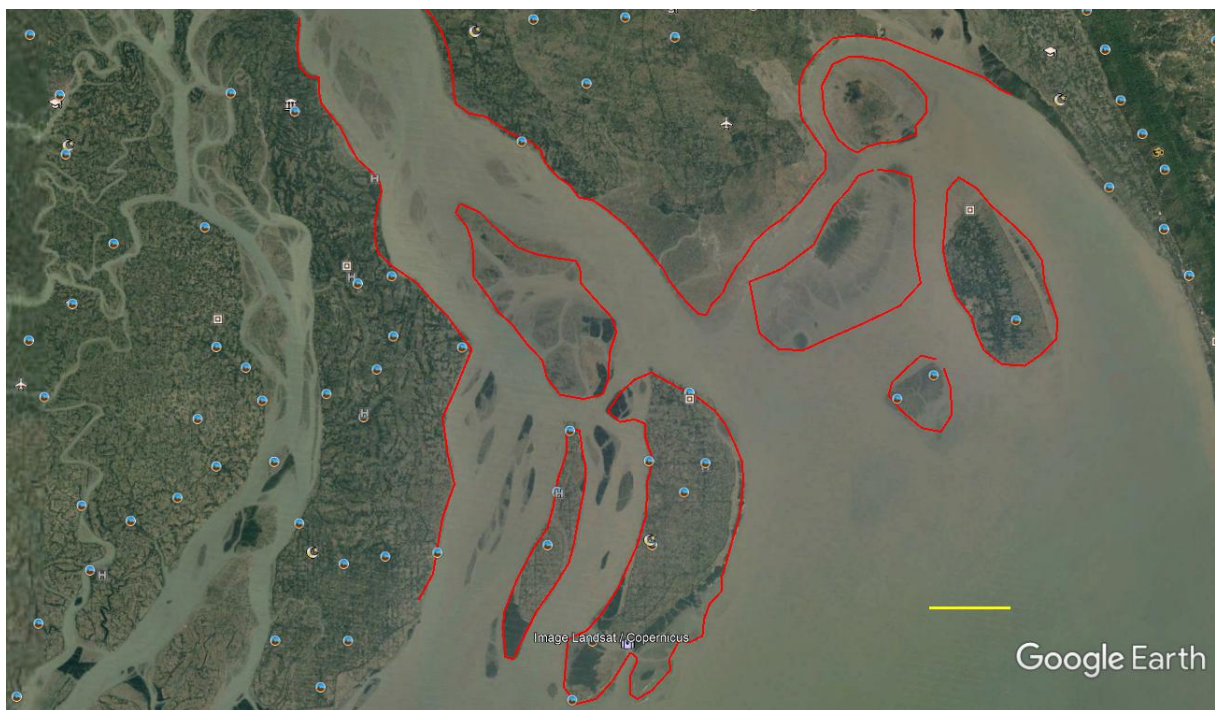
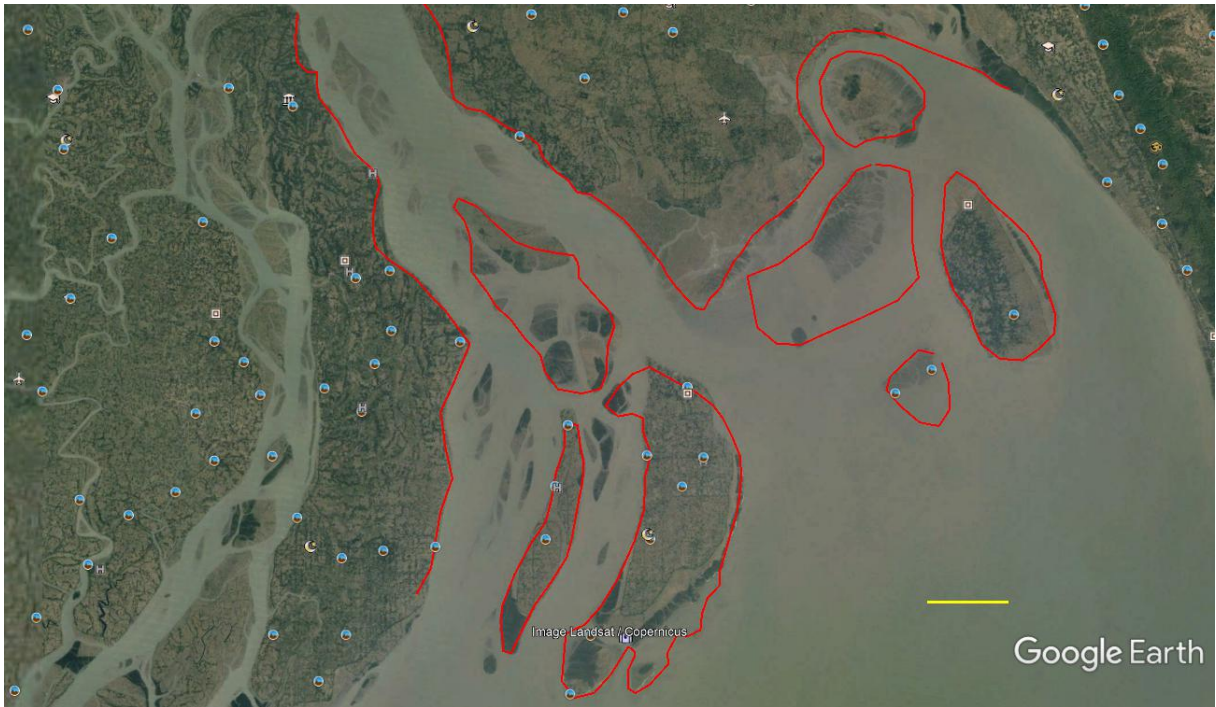
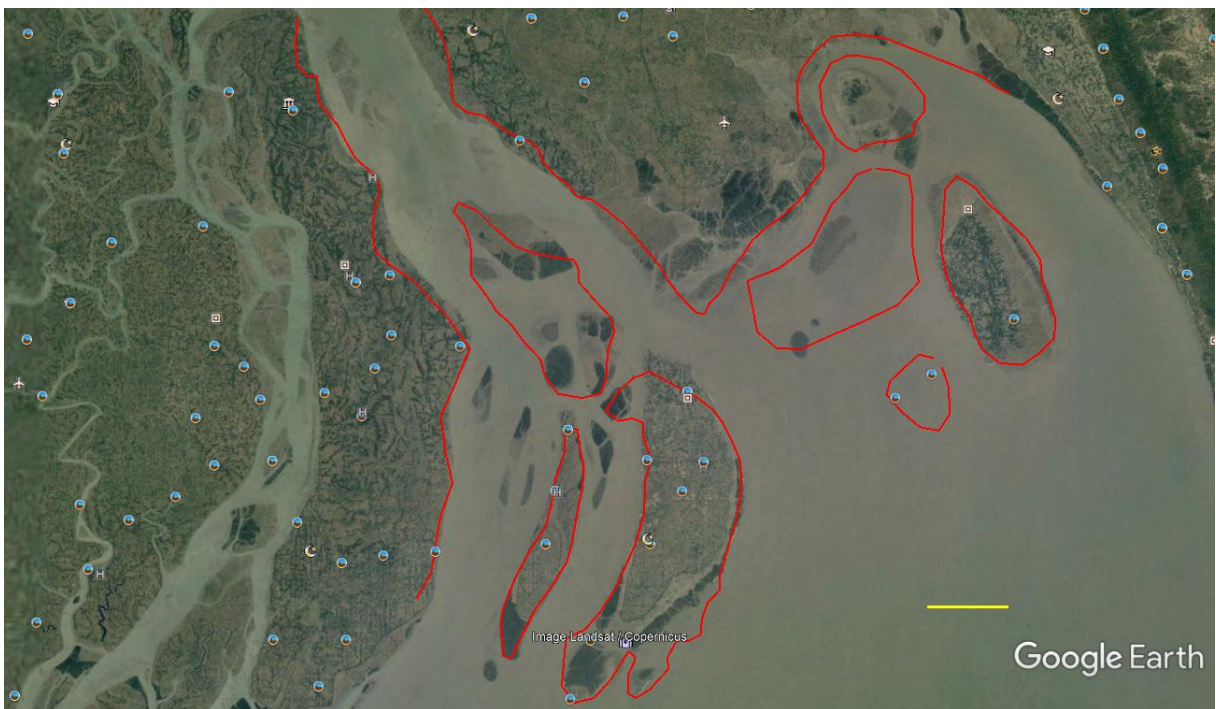
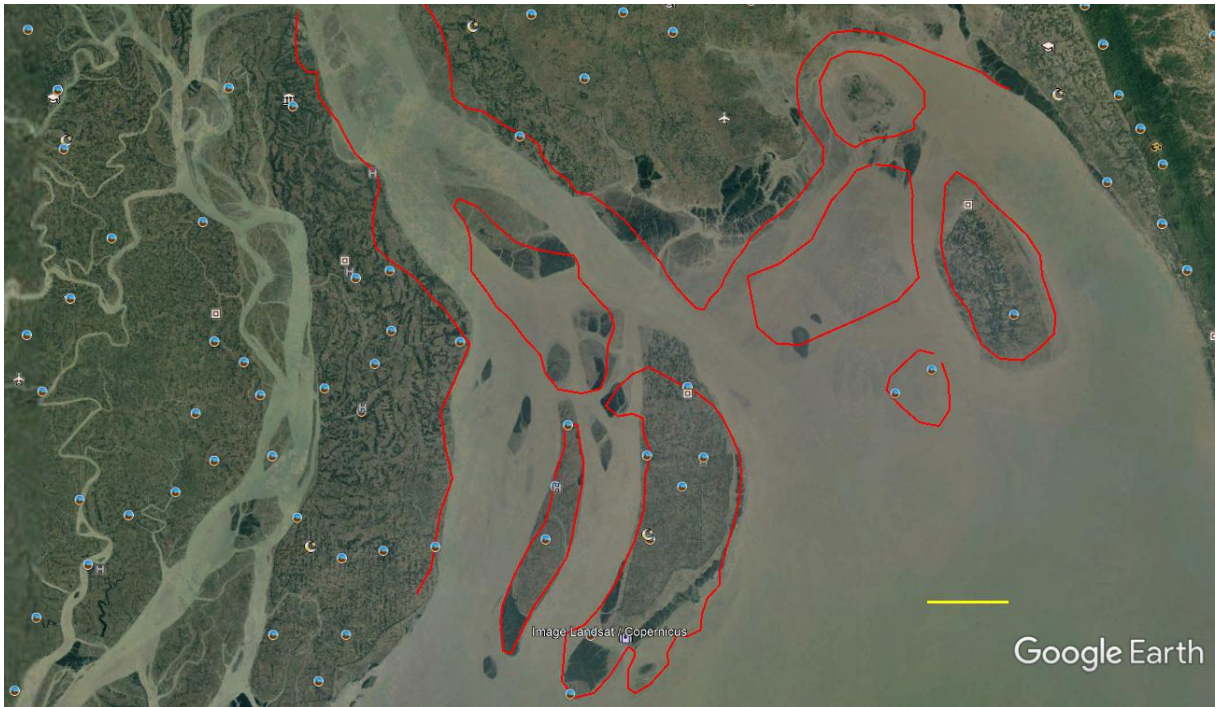
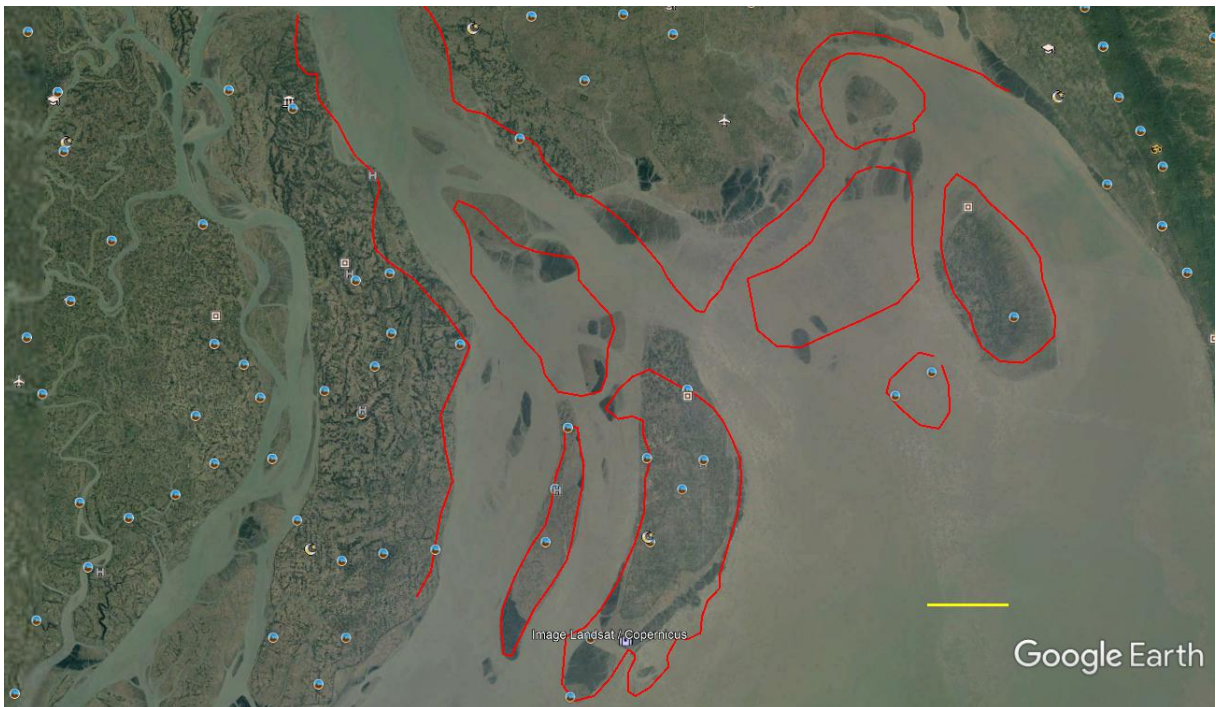
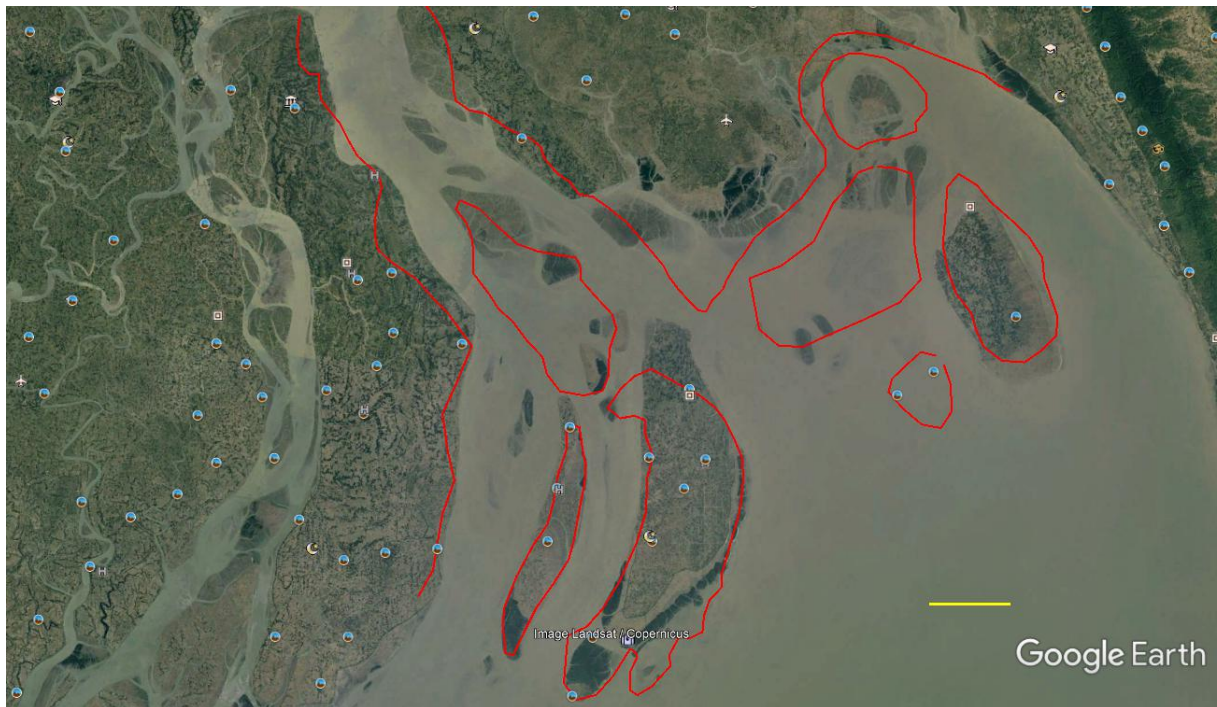
- Erosion of the Meghna bank near CSDP has been an ongoing trend since (at least) 1985; the same is the case for the North side of Hatiya Island.
- The Meghna channel between CSDP and Hatiya Island is growing. This is also a trend that has lasted for at least 30 years already.
- The second main channel system of the Meghna River between Hatiya Island and Bhola Island is silting up, resulting in the development of different chars in this area.
- Caring Char has grown up to approximately 2010; from then on it tends to erode.
- Jahazer Char has developed from non-existing and seems still to grow.
- South of Jahazer Char a new char is developing.

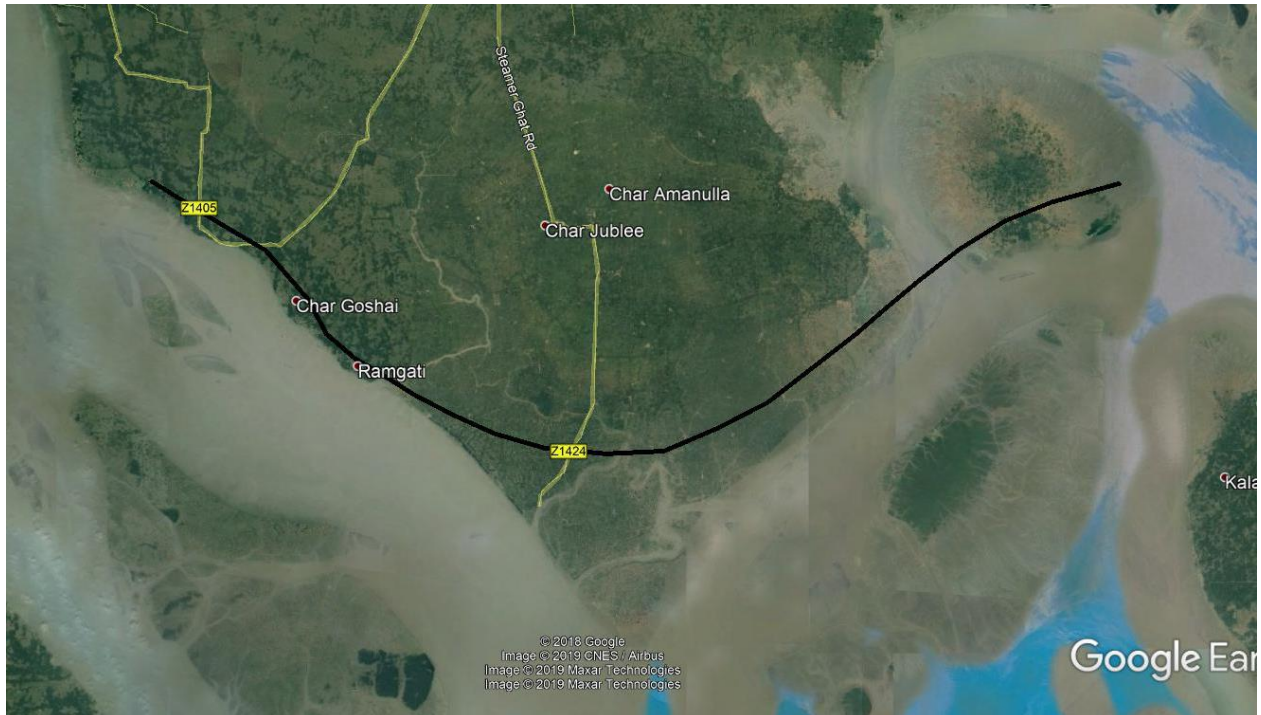
In the picture below an estimate is presented of where the bank line could be after say 10 years. This estimate implies that part of Boyer Char and almost the whole of Noler Char and Char Nangulia are at risk of being eroded.

Estimated safe bank line in CDSP III and IV area for the coming 10 years

All proposed activities of CDSP-B behind the estimated “safe” bank line after 10 years may continue as planned. It may also be considered to build new cyclone shelters in that zone to compensate for shelters that are lost in the eroded chars.

Note that the locations of the new retired sluices as proposed previously in the CDSP-B programme are outside the estimated safe bank line. Therefore these retired sluices should not be built under CDSP-B as long as the uncertainties on future development will remain high in coming years.
